MIDDLE POND DAM  
ME 0019C

PHASE I INSPECTION REPORT  
NATIONAL DAM INSPECTION PROGRAM

APRIL 1980

Identification No.: ME 00190  
Name of Dam: Middle Pond  
Town: York  
County and State: York, Maine  
Stream: Cider Hill Creek tributary to  
the York River  
Date of Site Visit: 16 November 1979

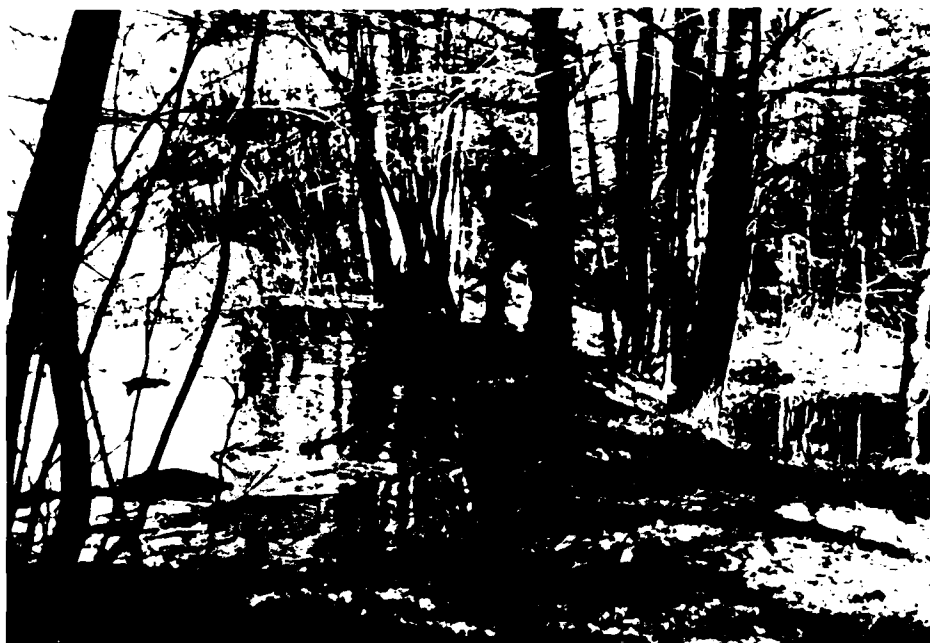
b. Dam. The 3-ft. high earth embankment, or dike, at the right side of the dam, Photo No. 2, is in satisfactory condition. The high reservoir level submerged the upstream slope and made examination of features on that side impossible. The crest is grown over with mature trees with exposed root systems, Photo No. 3. The horizontal and vertical alignment of the crest is indeterminate due to this condition. During the site examination water was ponded along the downstream side of the dike from recent rainfall and overtopping waves. Exposed bedrock occurs immediately downstream of the dike and at some locations is within 1 to 2 ft. of the crest elevation. The concrete core wall in the dike is believed to be bearing on rock.

2. Earth dike from right side of dam

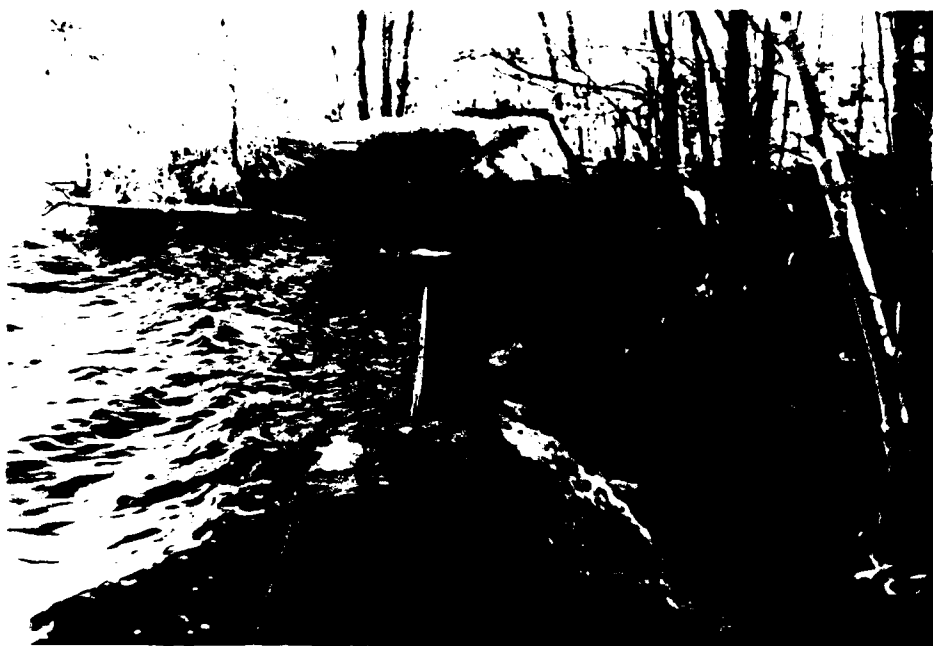
The concrete dike, Photo No. 4, is in fair to good condition. Efflorescence, spalling and erosion of the concrete is apparent but considered minor. The day of the site examination water was leaking through the flashboards as would be expected from the high reservoir level. The flashboard supports were rusted but both boards and pins appeared serviceable. Immediately downstream of the spillway section there are many trees, alive and dead, obstructing the discharge area, Photo No. 5.

4. Alignment of concrete dike and spillway
